Inspection Report

Property Address:
1324 Anywhere Street
Quincy IL 62301

Integrity Home Inspection

Date: 2/10/2010	Time: 08:00 AM	Report ID:
Property: 1324 Anywhere Street Quincy IL 62301	Customer: Mr. John Doe	Real Estate Professional:

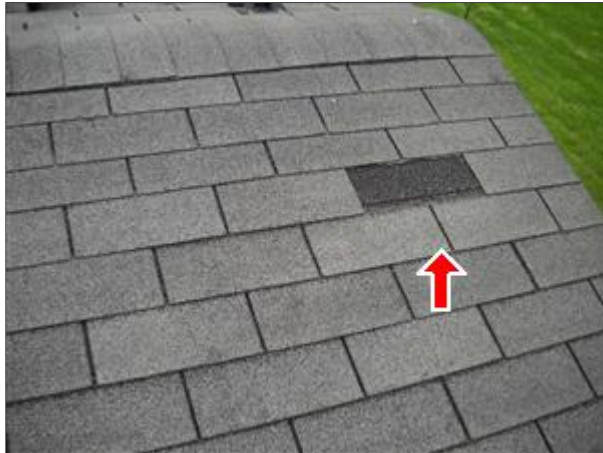
1.0 Picture 1

1.0 (1) The roof on the home has a few missing shingles. These should be replaced to stop the possibility of water entering home.

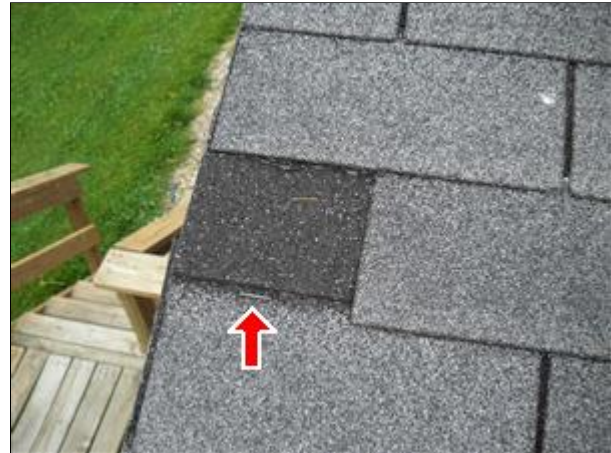
1.0 Picture 2

(2) There are unsealed fasteners in the roof. These should be sealed to stop the possibility of water from entering the roof.

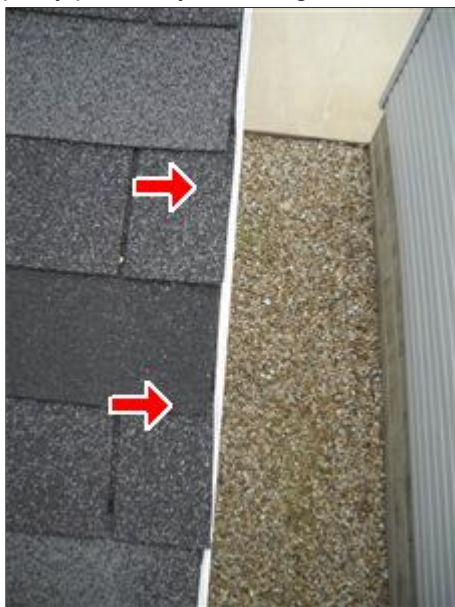
1.0 Picture 4

(3) The roof on the garage was short roofed at the gable edges allowing for rain to get to structure. Suggest that this be corrected to stop any possibility of damage due to moisture.

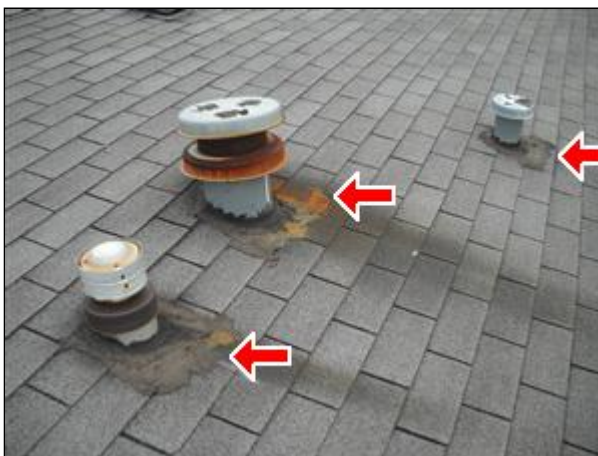
1.1 Picture 1

1.1 Repairs have been made by applying roof cement flashing areas of the vents protruding through the roof. Suggest that a more permanent repair be completed.

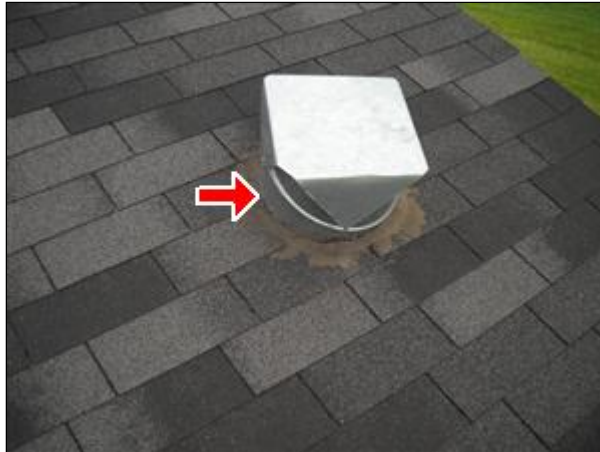
1.2 Picture 1

1.2 There is a vent going through the roofing the garage that serves no apparent purpose. This has been capped with a piece of metal.

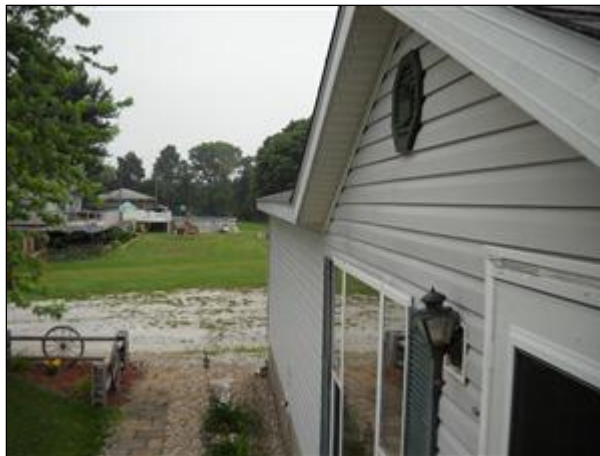
1.3 Picture 1

1.3 Suggest guttering be installed to divert rain water away from home and garage.

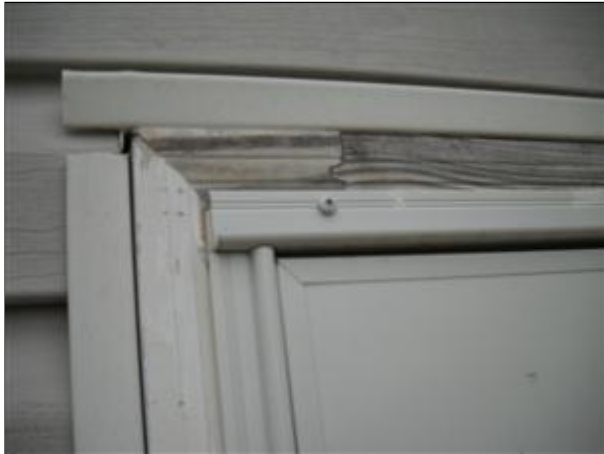
2.0 Picture 1

2.0 (1) There is exposed wood trim around doors on both the house and garage. This should be primed and painted to reduce the possibility of rot and decay.

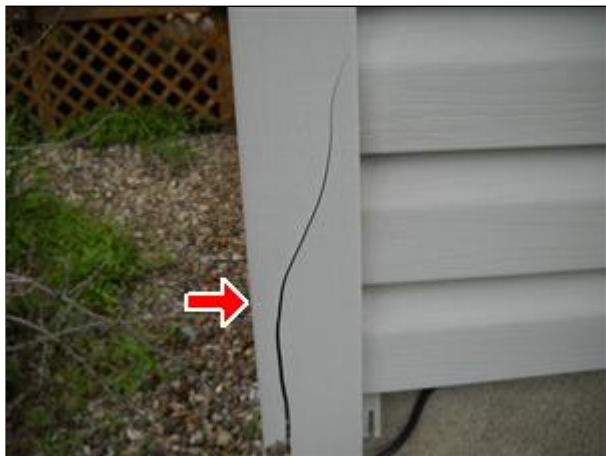
2.0 Picture 4

(2) There are various areas around the home and garage where the vinyl siding has been cracked or damaged due to heat. Some trims were also found to be cracked and damaged. These should be replaced or repaired to eliminate moisture getting into home.

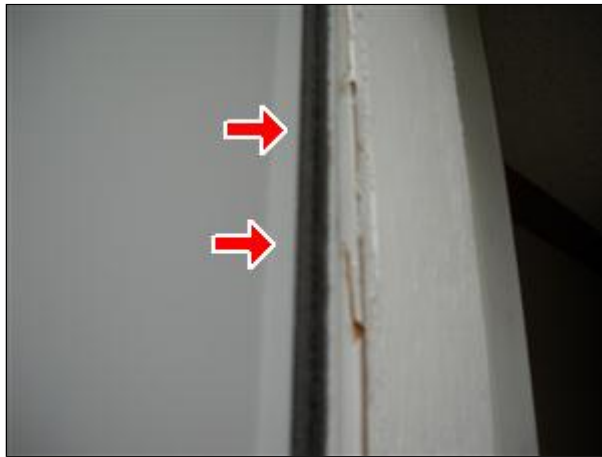
2.1 Picture 1

2.1 The front door has a cracked jamb that appears to have been covered.

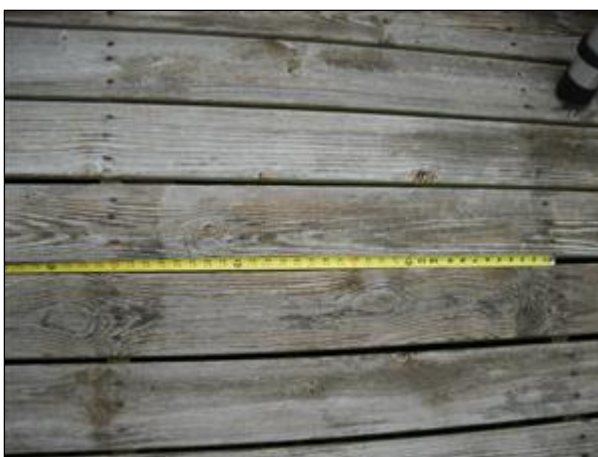
2.3 Picture 3

2.3 (1) On the front porch it appears that drywall screws are being used to support the joist hangers, screws are being used to connect joists to post and the span for the decking is 32 inches with large gaps between decking. Appropriate nails and bolts be used. Suggest a span of no more than 24 inches and correct spacing.

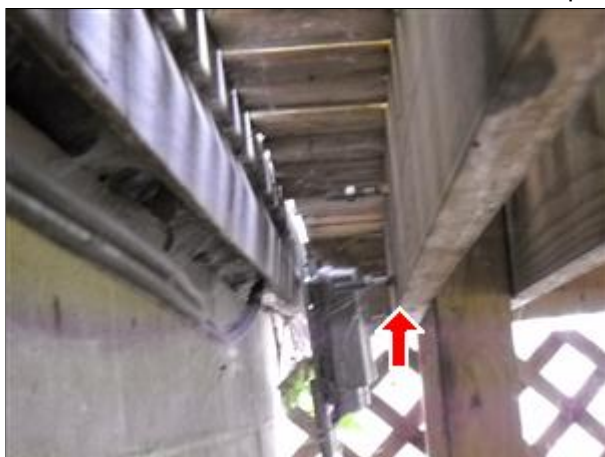
2.3 Picture 4

(2) On the back porch the wrong type of nails and screws are being used in the joist hangers, the bolts are too long that are connected in the beams to the posts and the balusters are only connected with one screw at each end. The span between joists are 39 inches and also has large gaps between decking. Suggest that a qualified person be consulted to replace the incorrect fasteners and correct the incorrect span and large gaps.

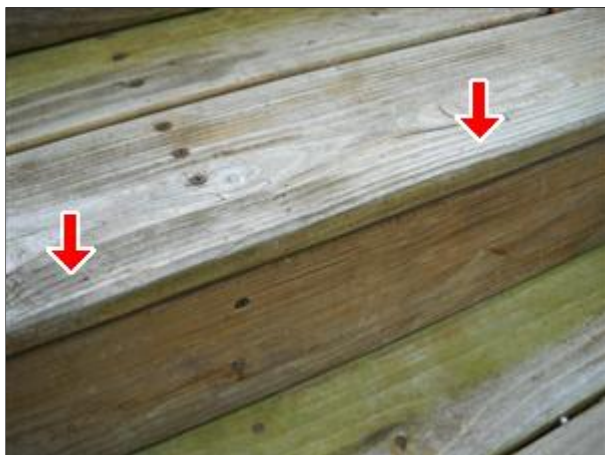
2.3 Picture 9

(3) Steps at both the front and rear of the home have no nosing on the thread. This is a trip hazard and should be corrected.

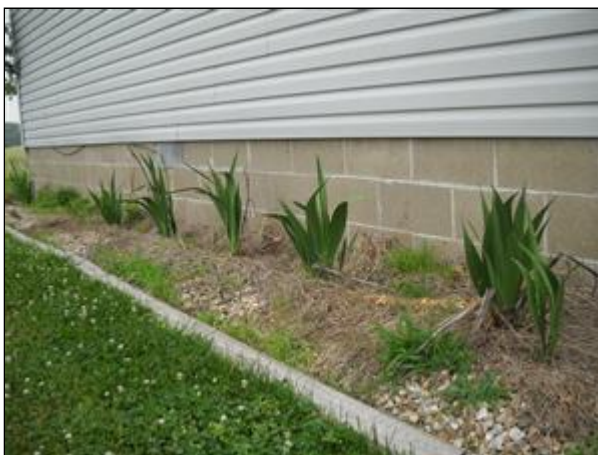
2.4 Picture 1

2.4 There are a few spots where the grading is a negative slope towards the building. This should be corrected to allow for water to drain away from home.

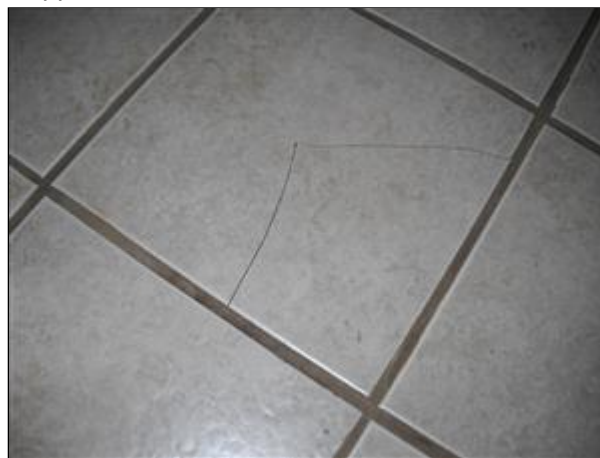
4.2 Picture 1

4.2 Tile cracked by island. Does not appear to be loose.

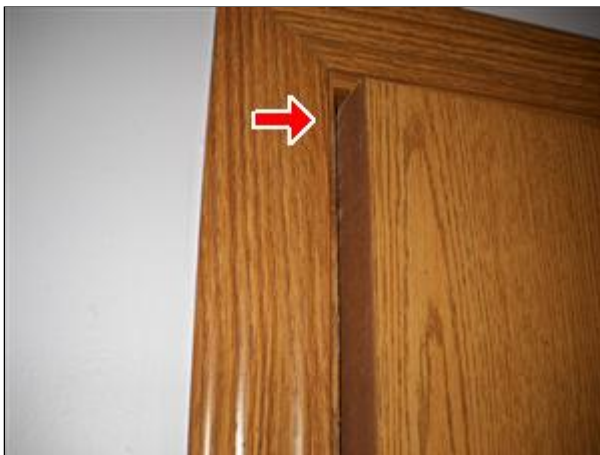
4.5 Picture 1

4.5 (1) The closet door in the bathroom hits the jamb when closing.

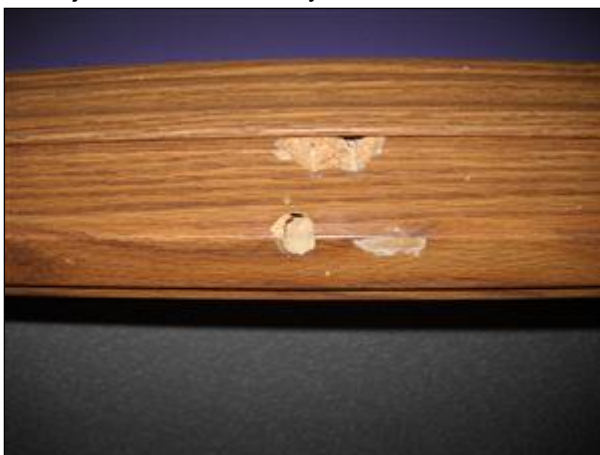
4.5 Picture 2

(2) There was some damage at the head jamb on the doorway into the master bedroom.

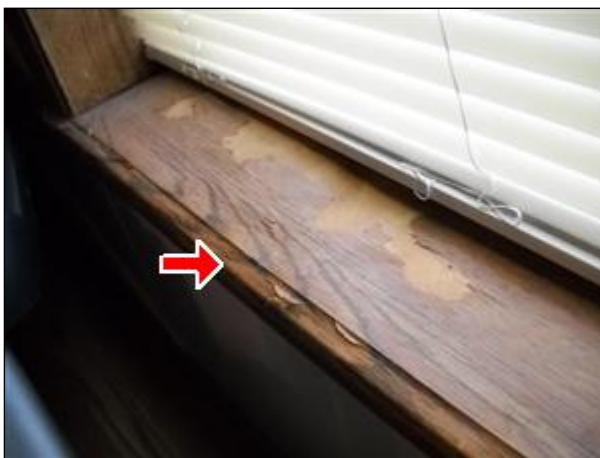
4.6 Picture 1

4.6 Moisture damage to window sill in bedroom

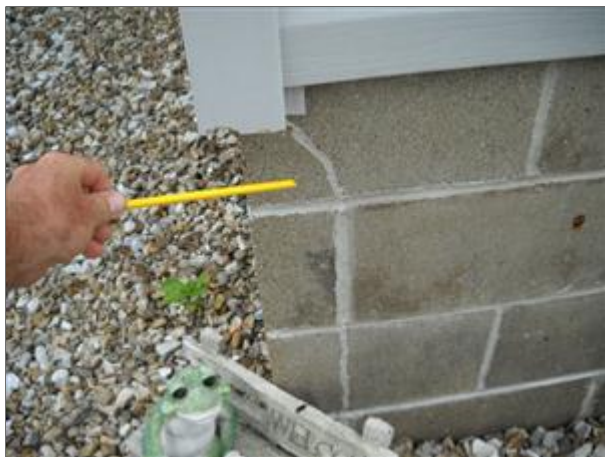
5.0 Picture 1

5.0 Small cracks were found in the block wall foundation. Suggest tuck pointing.

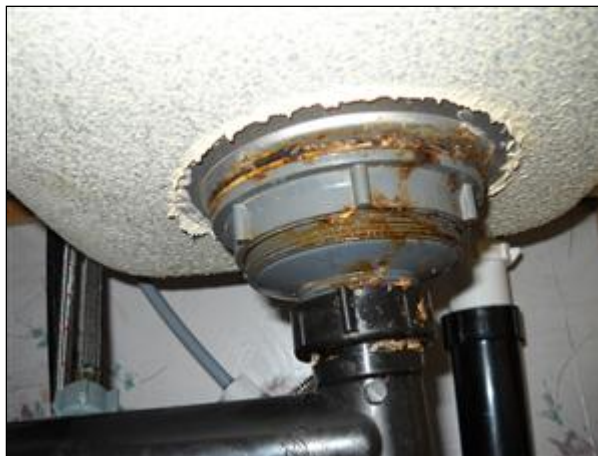
6.0 Picture 1

6.0 (1) Drain under the sink shows prior evidence of leaking. No leaking was observed at time of inspection.

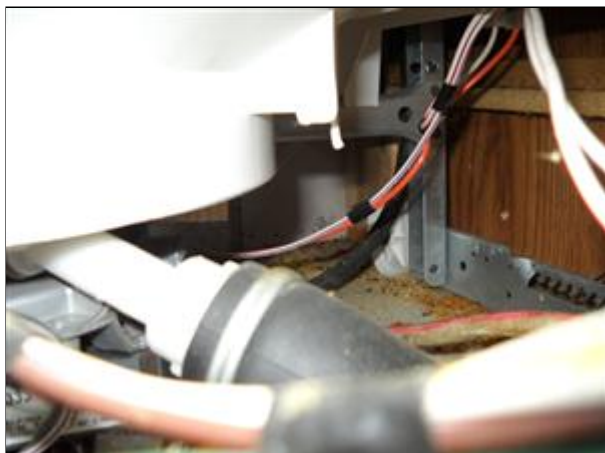
6.0 Picture 3

(3) Just FYI. There was steel wool found in many locations where plumbing comes through the floor. My best guess would be that this is to stop any mice from entering. what appears to be mice feces was seen underneath the dishwasher.

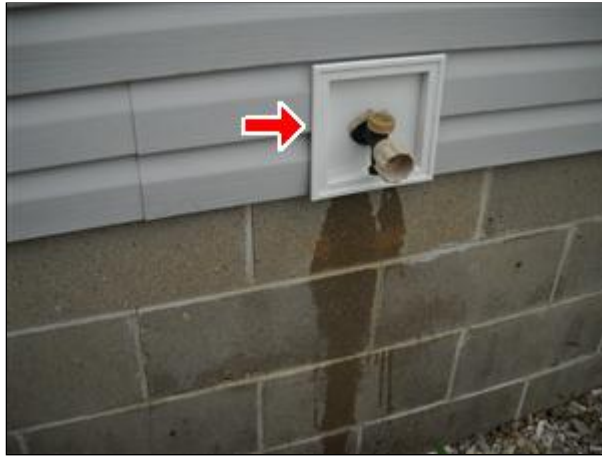
6.1 Picture 1

6.1 The outside hose bib on the front of the house is leaking inside crawlspace when turned on and needs to be replaced.

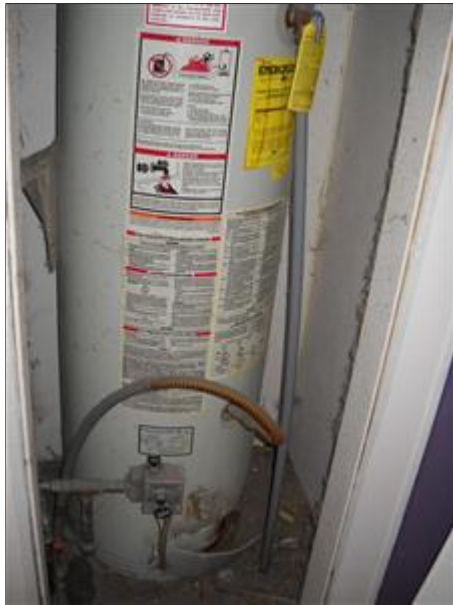
6.2 Picture 1

6.2 (1) The access to the water heater is through the closet in the master bedroom and requires removing six screws from a panel. The water heater is a 40 gallon and was working correctly at the time of inspection. Is not showing any signs of leaking at this time, however, it is getting old.

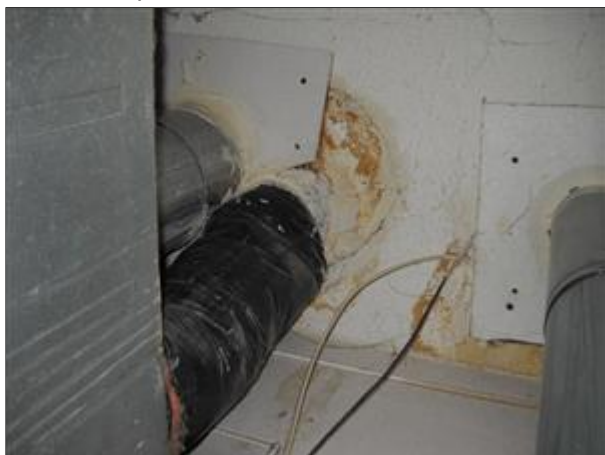
6.2 Picture 4

(2) The ceiling in the utility closet show signs of past leakage. There is staining on the flue pipe. There was no sign of leaking at time of inspection.

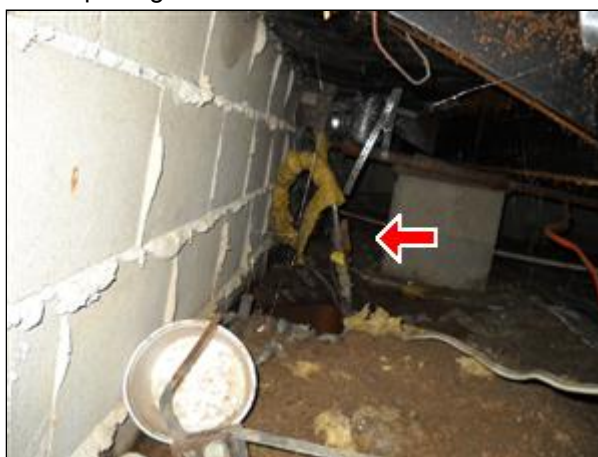
6.3 Picture 1

6.3 The main water shut off is accessible through the crawlspace scuttle hole next to the deck on the rear of the home. It is approximately 10 feet to the south of the opening.

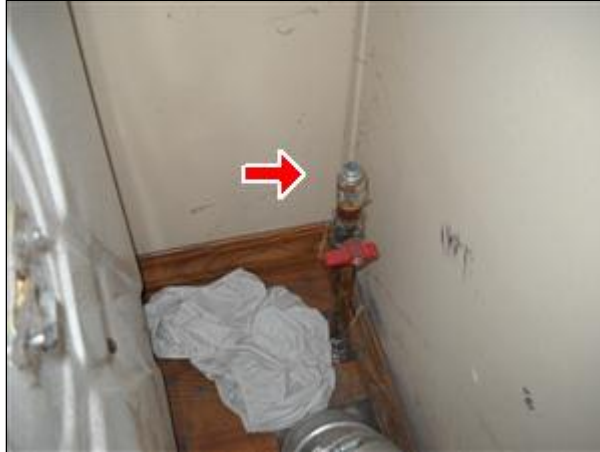
6.5 Picture 2

(2) The gas line behind the dryer needs a cap installed.

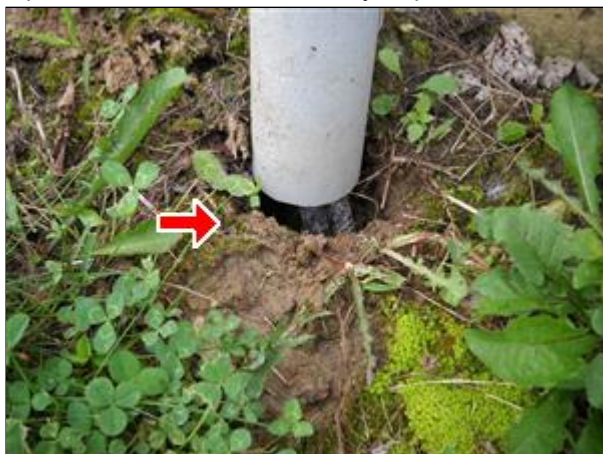
7.0 Picture 1

7.0 (1) The service entrance into the garage is leaving wiring exposed to possible mechanical damage. Pipe is being held by one strap This should be corrected by a qualified electrician.

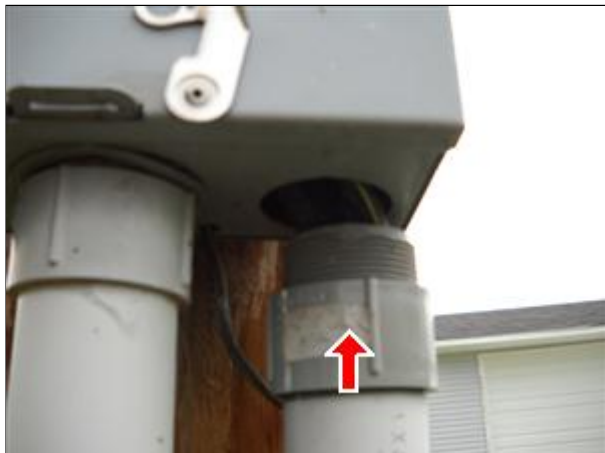
7.0 Picture 3

(2) The pipe has come loose from the main disconnect on the pole. This should be corrected by a qualified electrician.

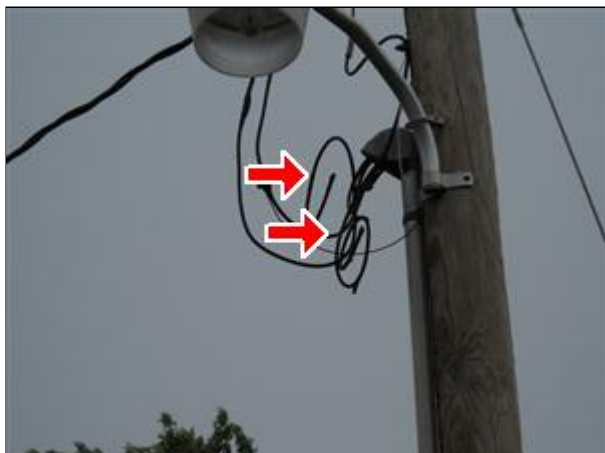
7.0 Picture 5

(3) There are wires exposed at the top of the pole that are connected to the main disconnect. This should be corrected by a qualified electrician.

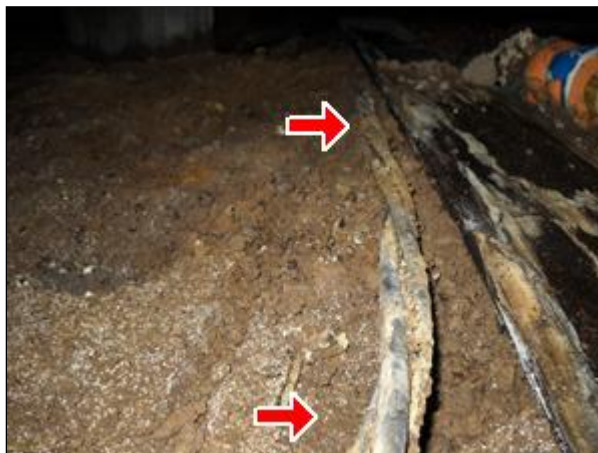
7.0 Picture 7

(4) The service cable is simply laying on the floor in the crawlspace and is subject to mechanical damage. This should be corrected by a qualified electrician.

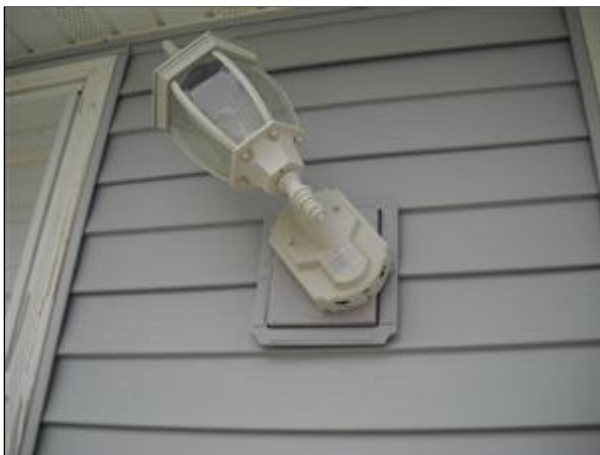
7.3 Picture 1

7.3 Fixtures on the front of the garage are not secure. This should be corrected by a qualified electrician.

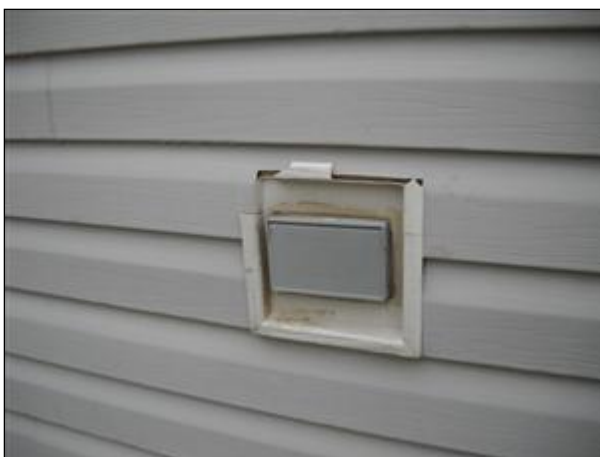
7.4 Picture 1

7.4 Electrical receptacle on the front of the home had no power to it at the time of inspection. suggest a qualified electrician be consulted.

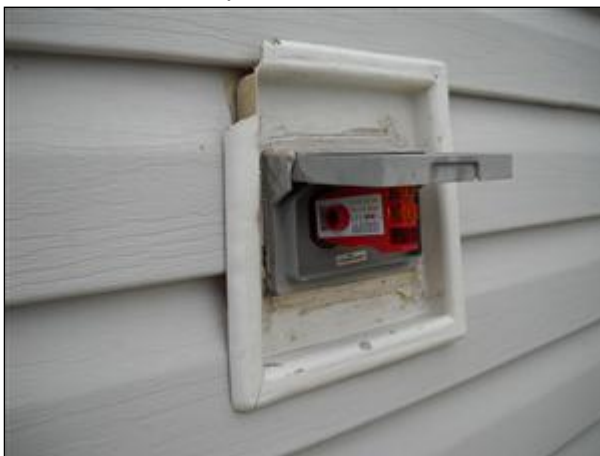
7.5 Picture 1

7.5 (1) Outlet of the East exterior of home is not GFCI protected.

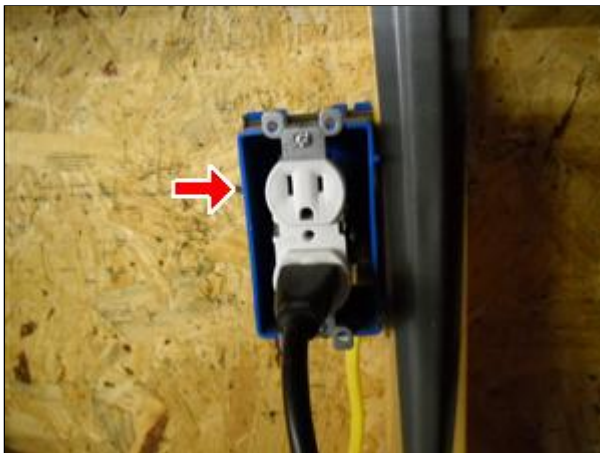
7.5 Picture 2

(2) No outlets in the garage were GFCI protected. Also no cover plates were installed. This should be corrected by a qualified electrician.

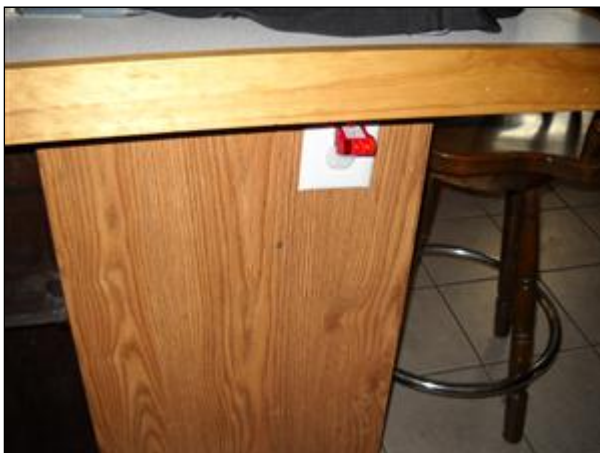
7.5 Picture 3

(3) The outlet on the island is not GFCI protected. This should be corrected by a qualified electrician.

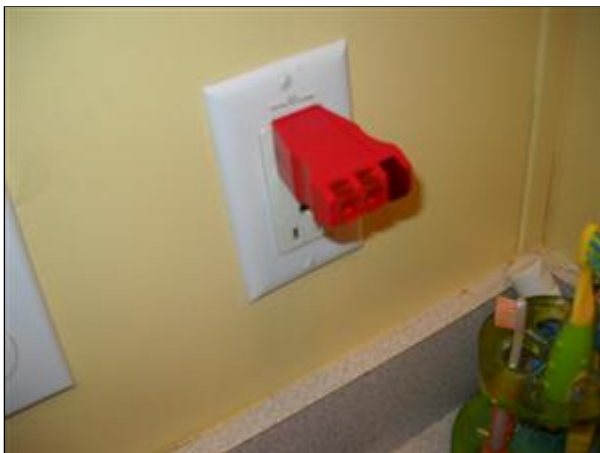
7.5 Picture 4

(4) Electrical outlet in the main bath had no power at the time of inspection. This should be corrected by a qualified electrician.

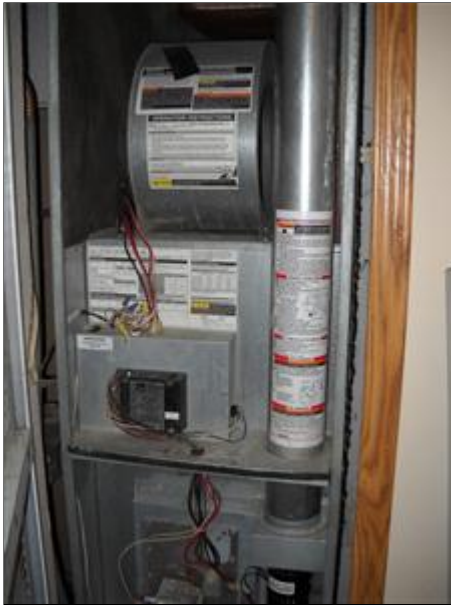
8.0 Picture 1

8.0 The furnace operated as expected. 70,000btu

Furnace equipped for use with: NAT. GAS

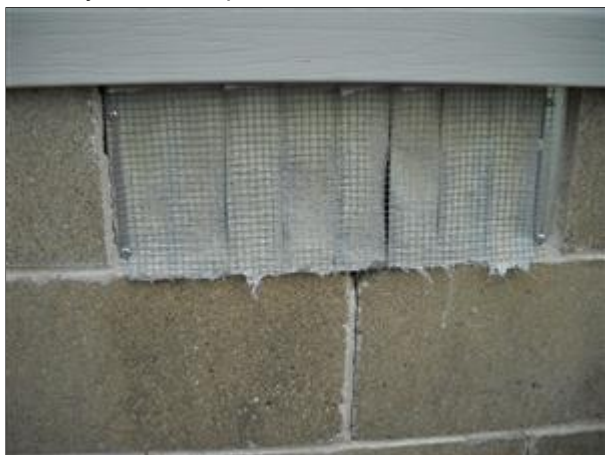
9.3 Picture 1

9.3 The foundation vents were sealed shut with tape. There was condensation on the underside of the insulation in the crawlspace. Crawlspace needs to breathe to prevent moisture buildup. Suggest removing the tape. Suggest temporarily using a fan to dry out crawlspace.

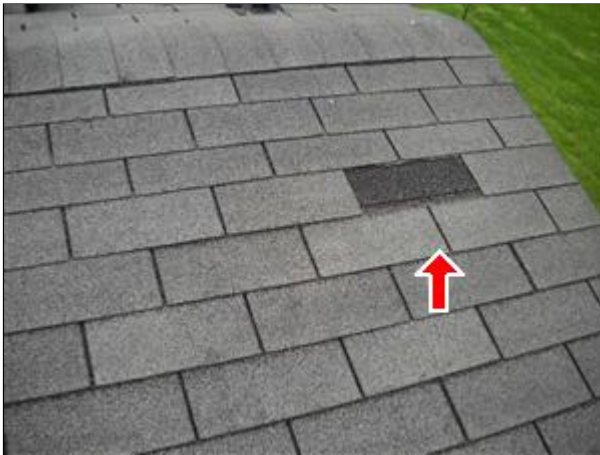
1.0 Picture 1

(1) The roof on the home has a few missing shingles. These should be replaced to stop the possibility of water entering home.

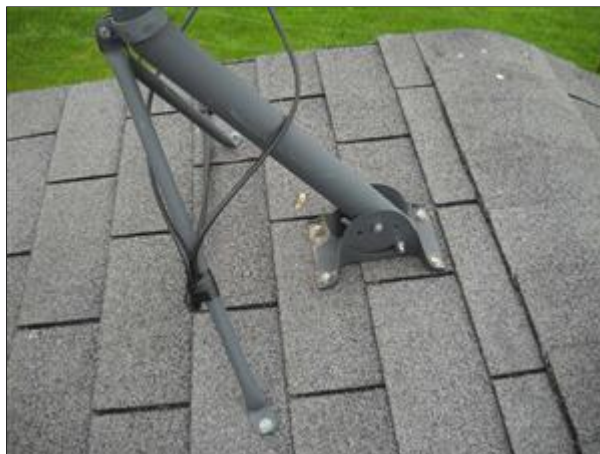
1.0 Picture 3

(2) There are unsealed fasteners in the roof. These should be sealed to stop the possibility of water from entering the roof.

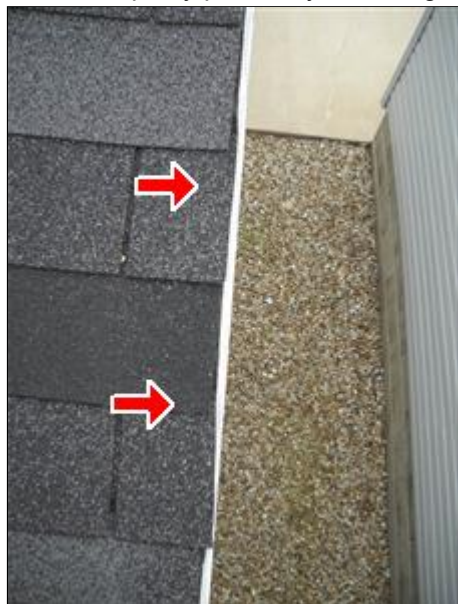
1.0 Picture 4

(3) The roof on the garage was short roofed at the gable edges allowing for rain to get to structure. Suggest that this be corrected to stop any possibility of damage due to moisture.

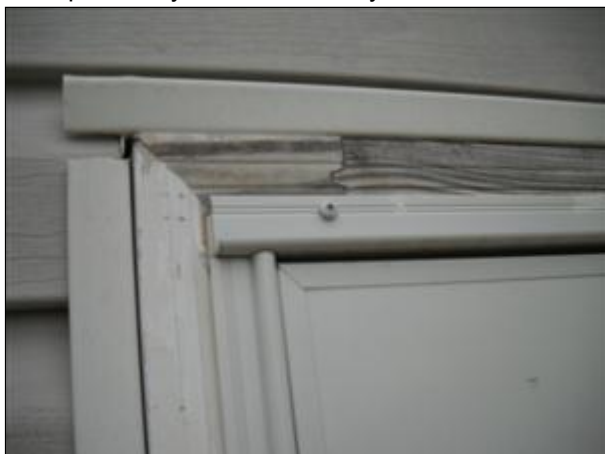
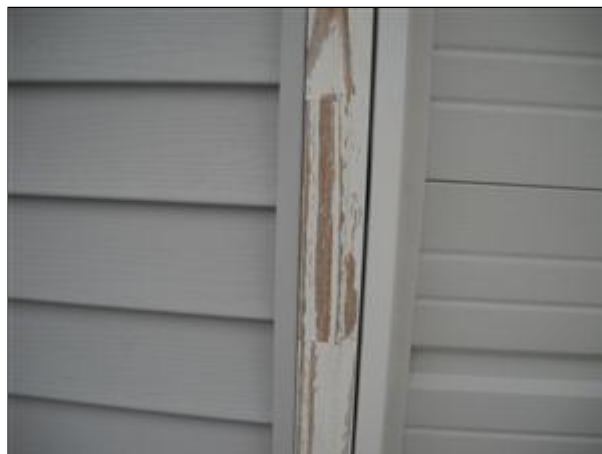
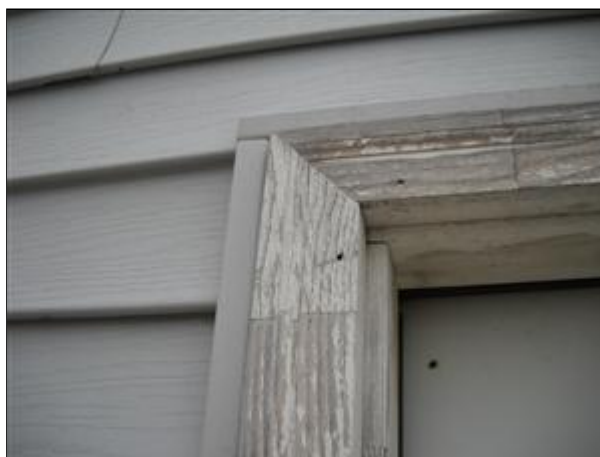
(1) There is exposed wood trim around doors on both the house and garage. This should be primed and painted to reduce the possibility of rot and decay.

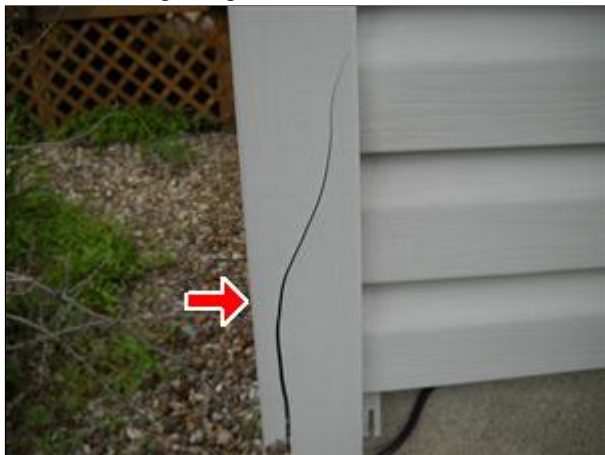
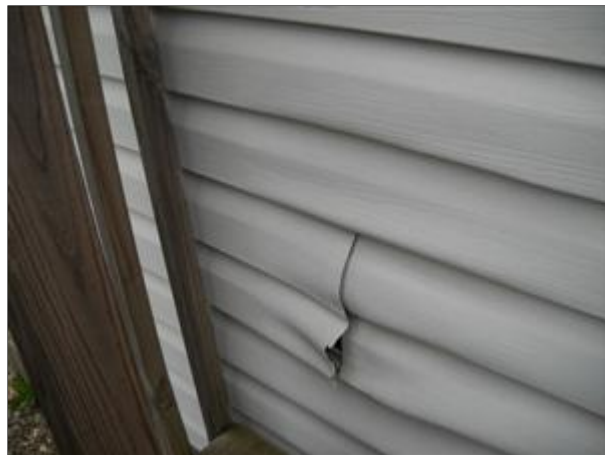
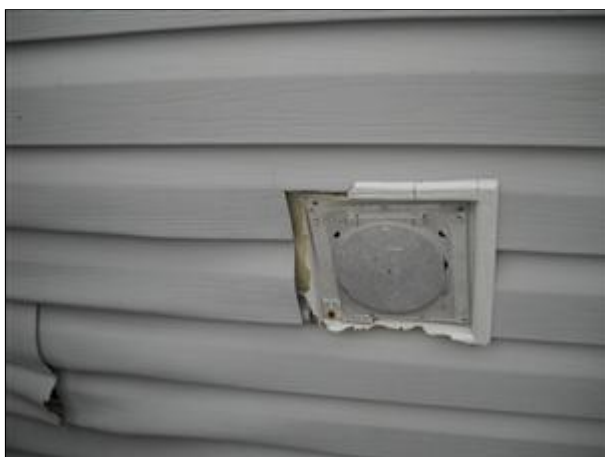
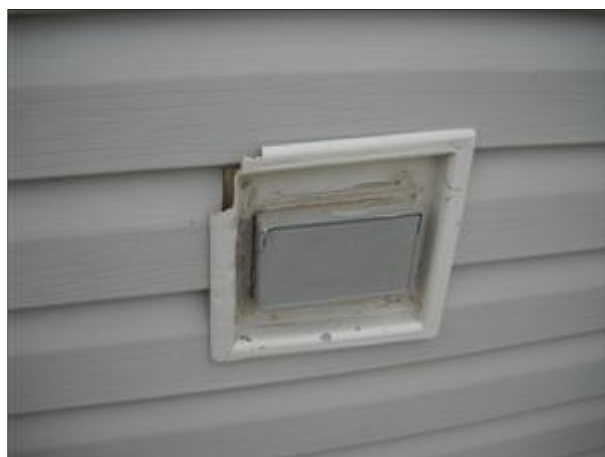
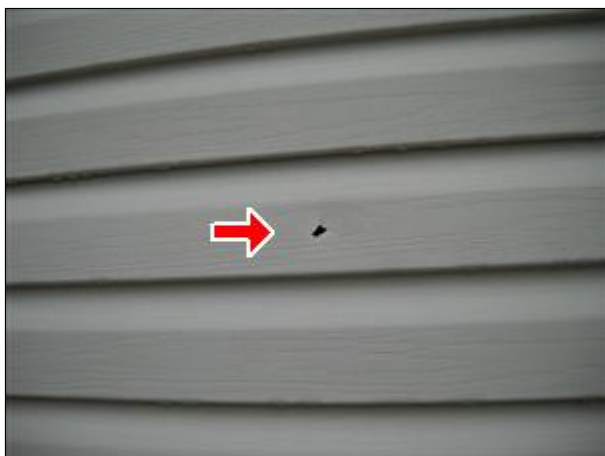
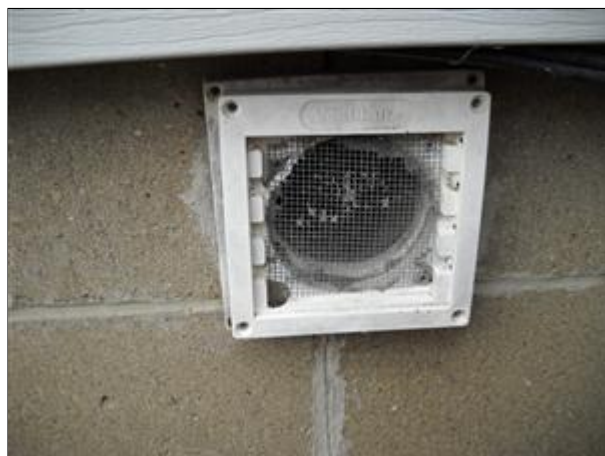
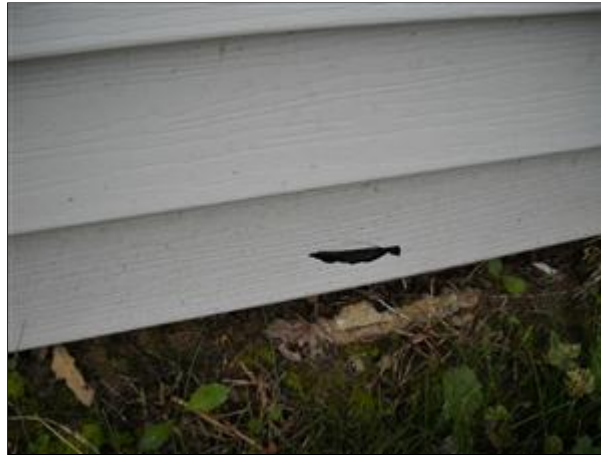
(2) There are various areas around the home and garage where the vinyl siding has been cracked or damaged due to heat. Some trims were also found to be cracked and damaged. These should be replaced or repaired to eliminate moisture getting into home.

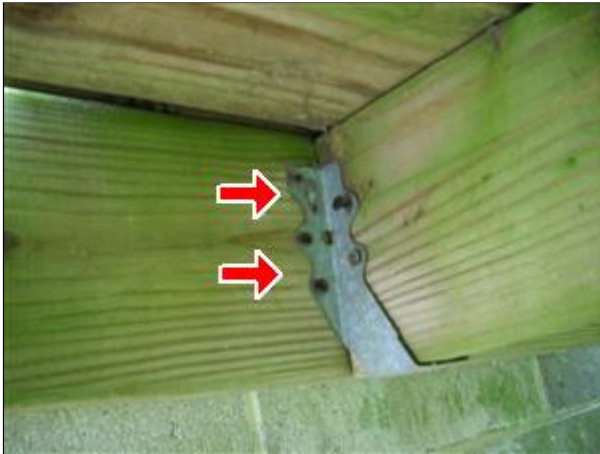
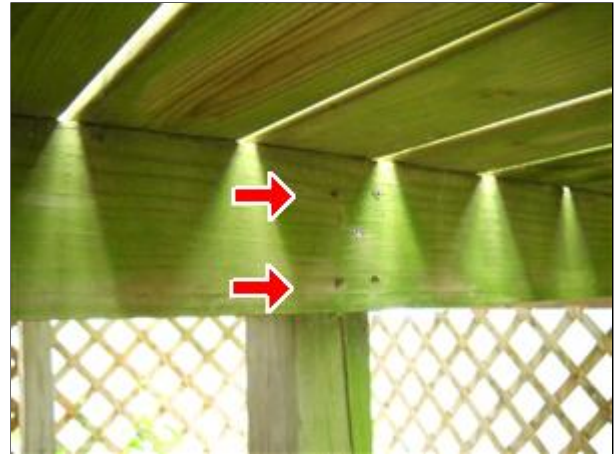
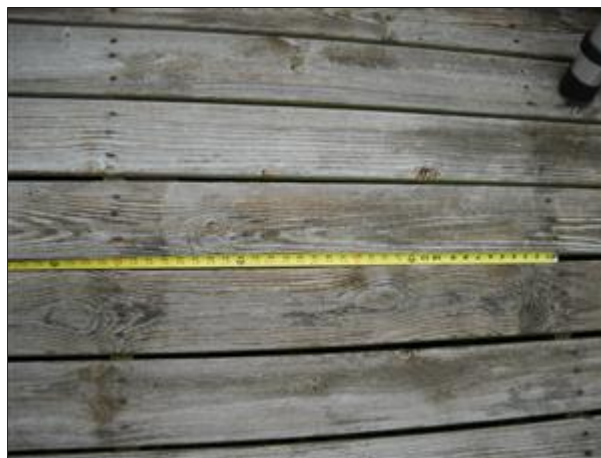
(1) On the front porch it appears that drywall screws are being used to support the joist hangers, screws are being used to connect joists to post and the span for the decking is 32 inches with large gaps between decking. Appropriate nails and bolts be used. Suggest a span of no more than 24 inches and correct spacing.

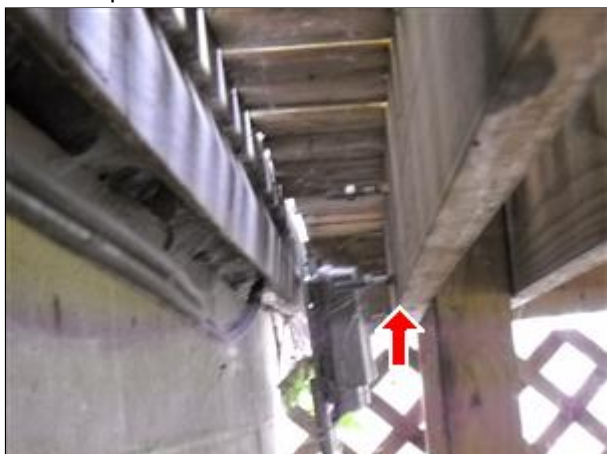
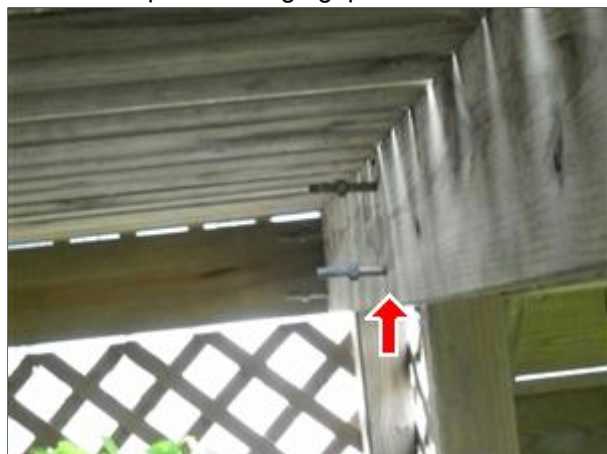
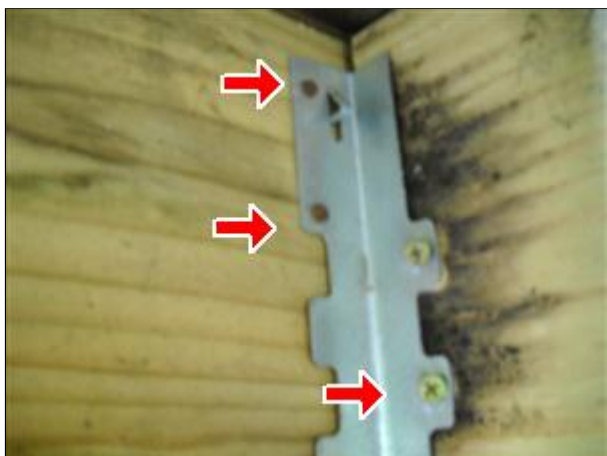
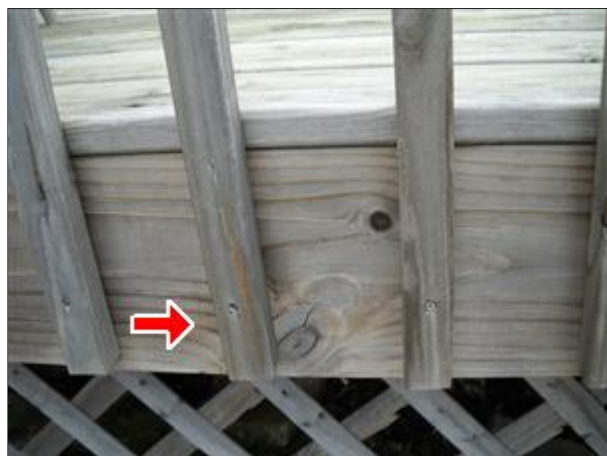
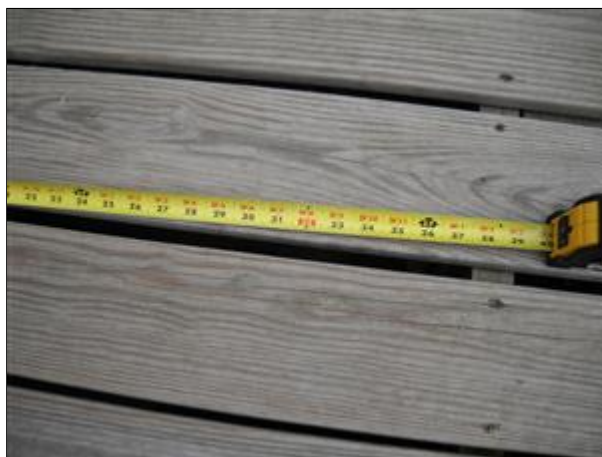
(2) On the back porch the wrong type of nails and screws are being used in the joist hangers, the bolts are too long that are connected in the beams to the posts and the balusters are only connected with one screw at each end. The

span between joists are 39 inches and also has large gaps between decking. Suggest that a qualified person be consulted to replace the incorrect fasteners and correct the incorrect span and large gaps.

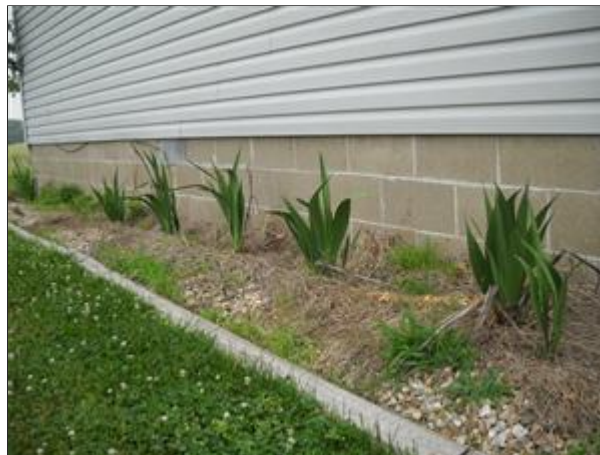
2.4 Picture 1

There are a few spots where the grading is a negative slope towards the building. This should be corrected to allow for water to drain away from home.

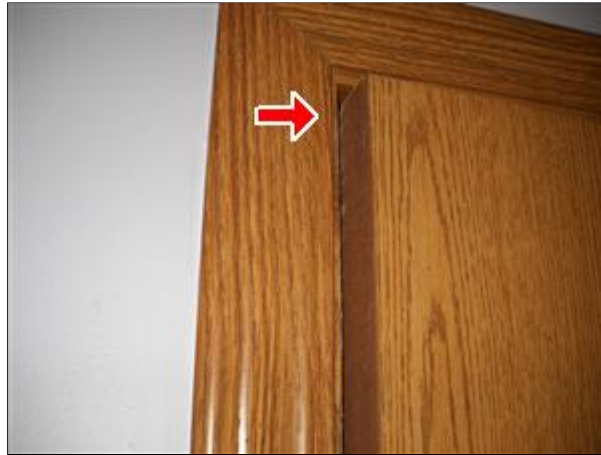
4.5 Picture 1

(1) The closet door in the bathroom hits the jamb when closing.

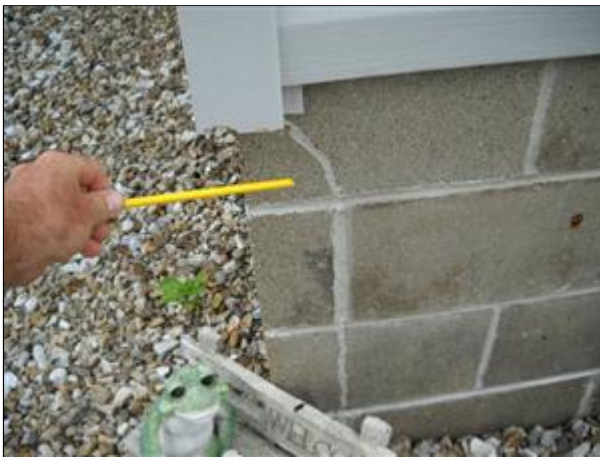
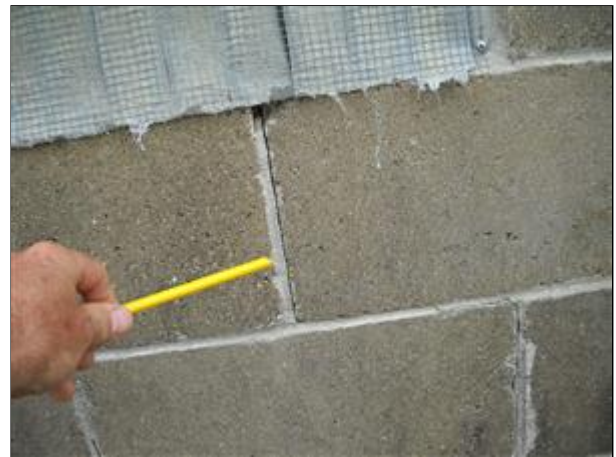
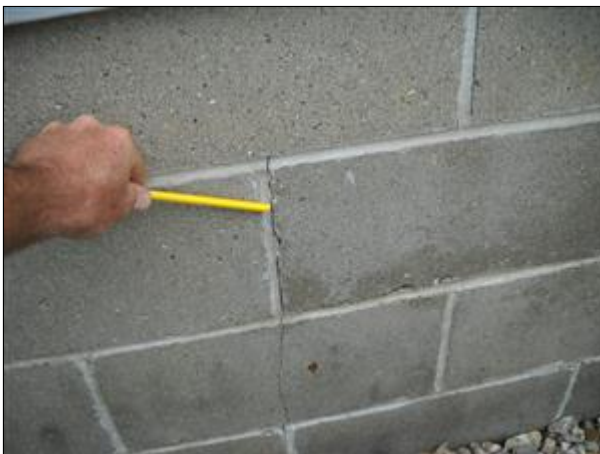
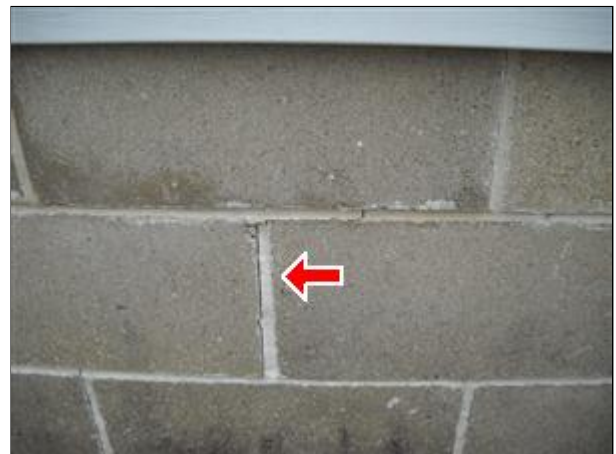
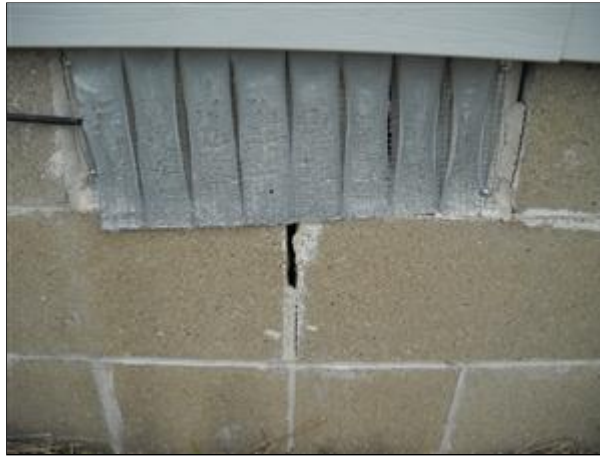
Small cracks were found in the block wall foundation. Suggest tuck pointing.

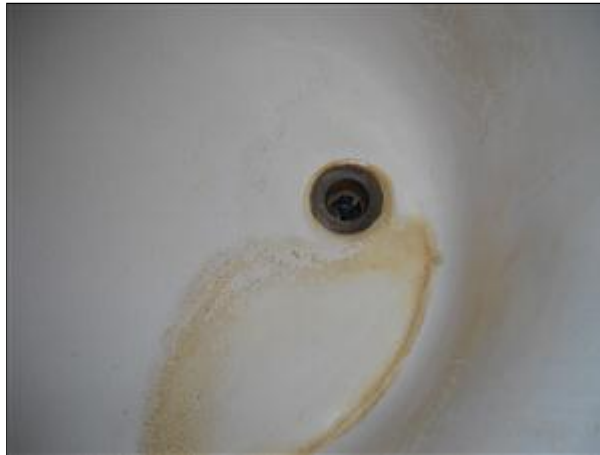
6.0 Picture 2

(2) The tub drain in the master bath is lacking a mechanical stopper. Currently a rubber stopper is being used.

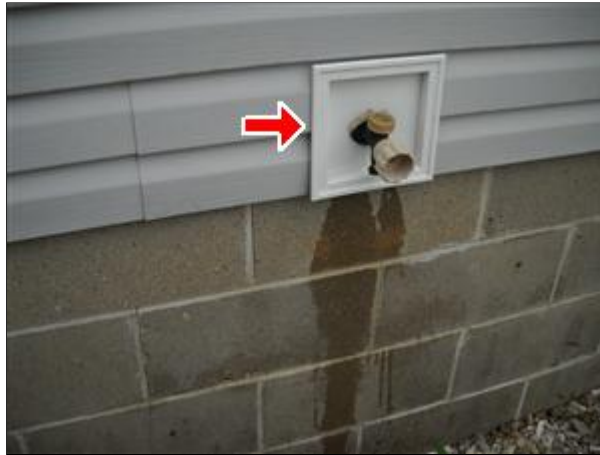
6.1 Picture 1

The outside hose bib on the front of the house is leaking inside crawlspace when turned on and needs to be replaced.

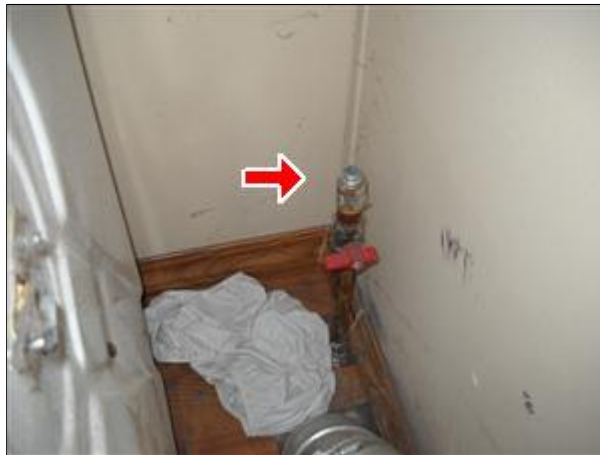
6.5 Picture 2

(2) The gas line behind the dryer needs a cap installed.

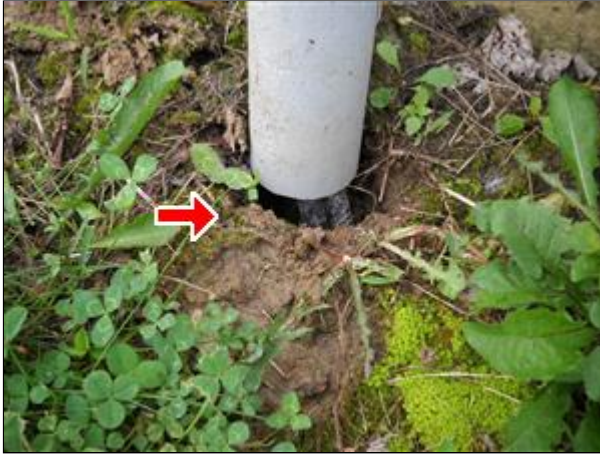
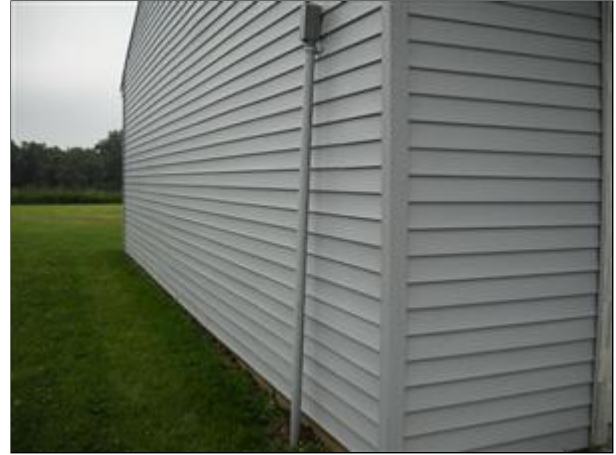
(1) The service entrance into the garage is leaving wiring exposed to possible mechanical damage. Pipe is being held by one strap This should be corrected by a qualified electrician.

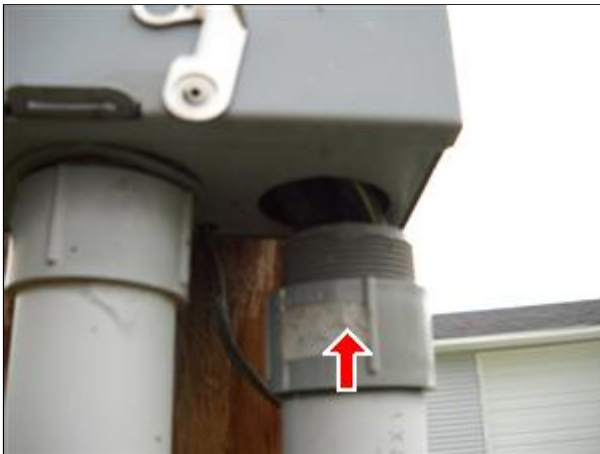
7.0 Picture 3

(2) The pipe has come loose from the main disconnect on the pole. This should be corrected by a qualified electrician.

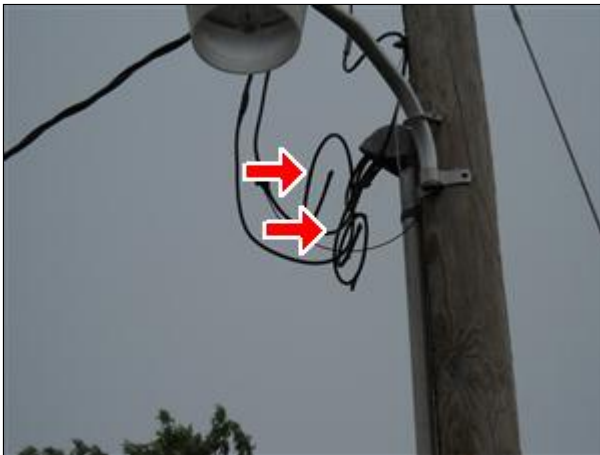
7.0 Picture 5

(3) There are wires exposed at the top of the pole that are connected to the main disconnect. This should be corrected by a qualified electrician.

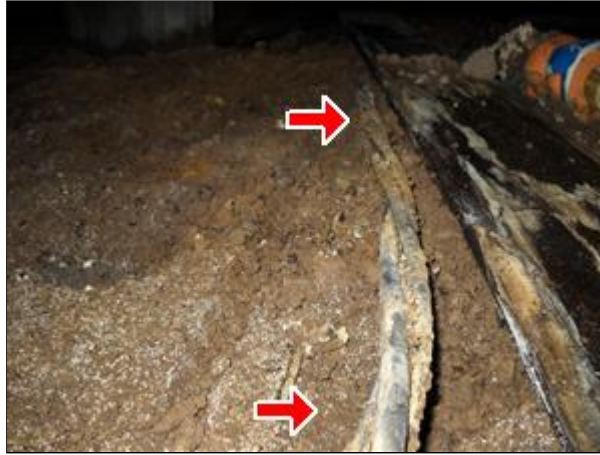
7.0 Picture 7

(4) The service cable is simply laying on the floor in the crawlspace and is subject to mechanical damage. This should be corrected by a qualified electrician.

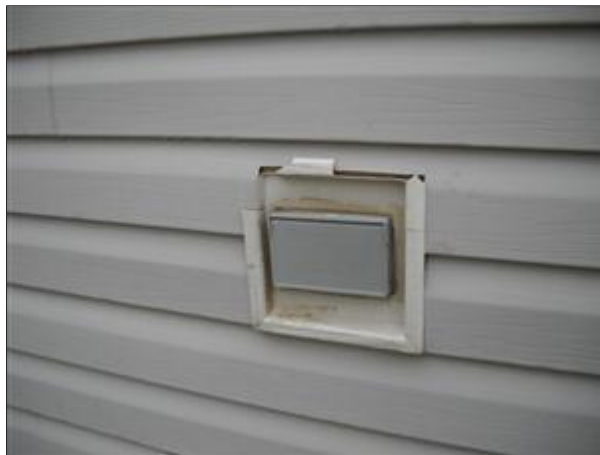
7.4 Picture 1

Electrical receptacle on the front of the home had no power to it at the time of inspection. suggest a qualified electrician be consulted.
