Inspection Report

Property Address:
1324 Anywhere Street
Quincy IL 62301

Integrity Home Inspection

Date: 2/10/2010	Time: 08:00 AM	Report ID:
Property: 1324 Anywhere Street Quincy IL 62301	Customer: Mr. John Doe	Real Estate Professional:

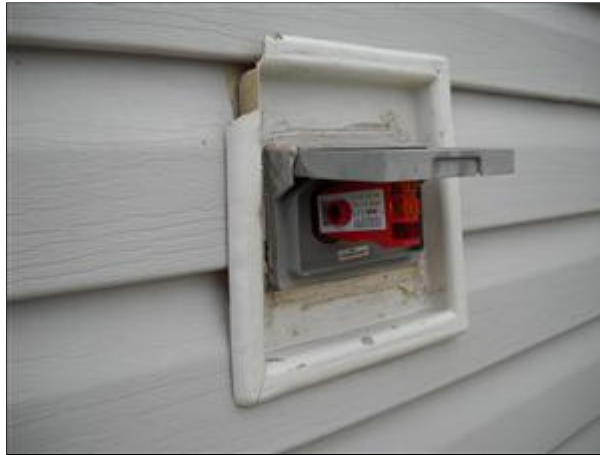
7.5 Picture 1

(1) Outlet of the East exterior of home is not GFCI protected.

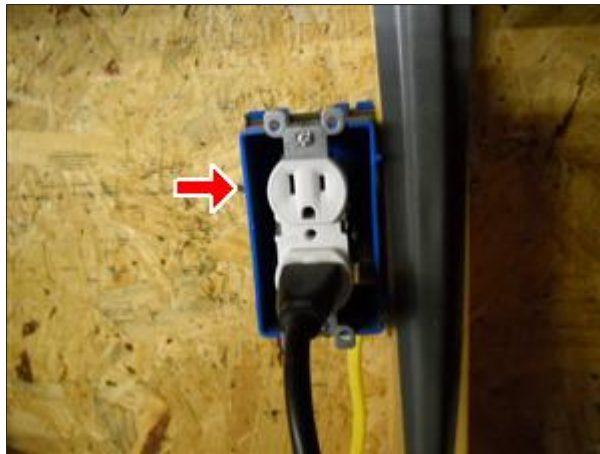
7.5 Picture 2

(2) No outlets in the garage were GFCI protected. Also no cover plates were installed. This should be corrected by a qualified electrician.

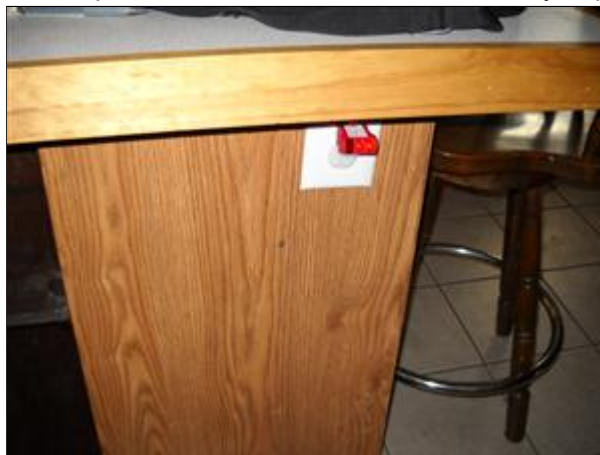
7.5 Picture 3

(3) The outlet on the island is not GFCI protected. This should be corrected by a qualified electrician.

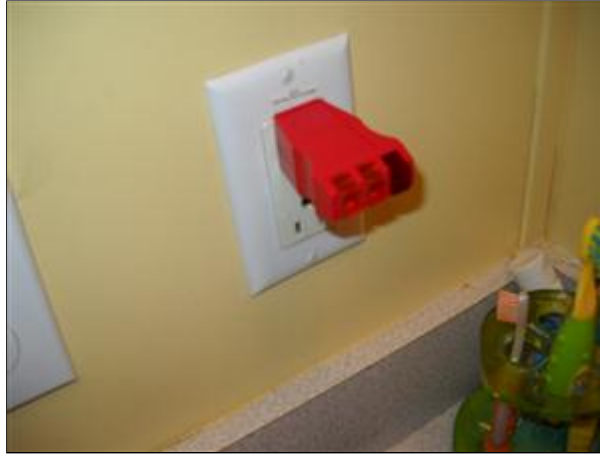
7.5 Picture 4

(4) Electrical outlet in the main bath had no power at the time of inspection. This should be corrected by a qualified electrician.

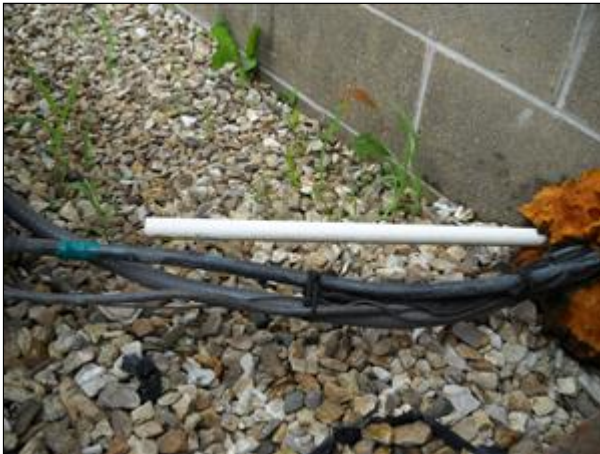
8.7 Picture 1

The condensation drain slopes back toward the home. Suggest sloping away to keep moisture away from foundation. Drain is unsupported in basement.

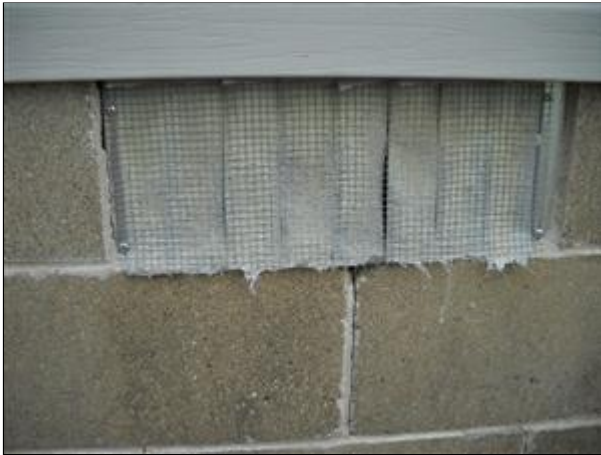
9.3 Picture 1

The foundation vents were sealed shut with tape. There was condensation on the underside of the insulation in the crawlspace. Crawlspace needs to breathe to prevent moisture buildup. Suggest removing the tape. Suggest temporarily using a fan to dry out crawlspace.
